Case study on the failure analysis of turbojet compressor blades

With a turbojet compressor that had its blades fractured during laboratory tests, this work carried out a failure analysis aiming at characterizing the problem, identifying the fracture mechanism and proposing a potential post-manufacturing improvement. Typical steps of a failure analysis were performed, including visual and fractographic analyzes via stereomicroscopy and scanning electron microscopy. The evidence indicated that the component failed due to fatigue, with the presence of very evident striations on the fracture surface, due to a high surface roughness. Therefore, it was considered suitable to propose a shot peening treatment on the product as a way of inducing residual compressive stresses and hindering the process of nucleation of a fatigue crack.

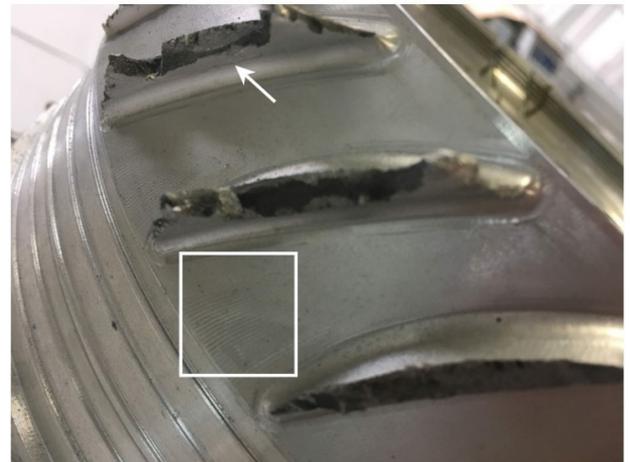
The component is composed of a metallic cylindrical body with blades along its entire radial extension, which were all fractured (on all four rows of blades) during mechanical laboratory tests. The piece has average dimensions of 200 mm in diameter and 220 mm in height, and the blades of the upper row, two of which were extracted for fractographic analysis, are 43 mm long. Figure 2 shows some surface discontinuities of the part. The square highlights the surface roughness on the part derived from the machining process to which the part is subjected during its manufacture. The arrow shows a crack at the base of the fractured blade, which is parallel to the fracture surface plane. It is worth mentioning that the surface presents a difference in the topographic profile, with peaks and valleys.

Figure 2. Photographic record of the fractured component with emphasis on surface discontinuities.

likely to produce stress concentrators and facilitators of crack nucleation on the surface. Although the surface finishing was visually rough over the entire surface of the compressor, the regions near the exit of the radius of curvature between the blades and the compressor body had a slightly worse finishing. This difference can be noted in Figure 4(a), where a rougher surface is seen above the black dotted line towards the radius. This might be ascribed to some instability during the machining process. The roughness measurements obtained on the surface of a fractured blade and on a surface close to the radius of curvature are shown in Table 1. The mean values of both Ra and Rz are actually higher on the surface close to the radius, although the standard deviation values statistically minimize this difference.

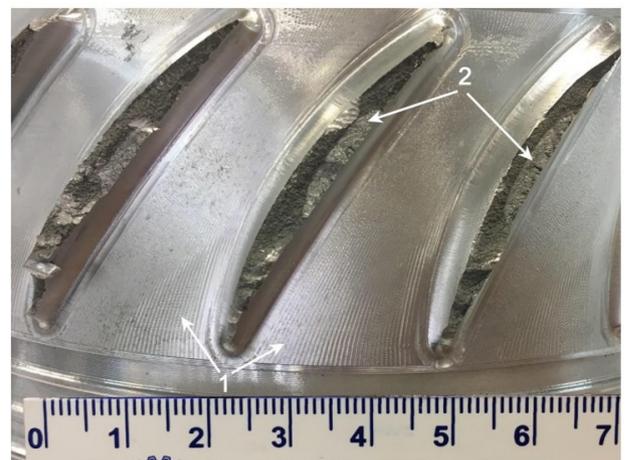
In Figure 3, the set of arrows number 1 again highlights the existing roughness along the surface of the part, which even extends to the region of the surface of the blades. Another discontinuity observed is highlighted

Figure 3. Photographic record of the fractured component, highlighting, in addition to the discontinuities, the fracture surface.

by the set of arrows number 2, where it is possible to identify a difference in shade on the fracture surface of the blades, which has a lighter region in an elliptical shape and the remaining area with a darker shade. Regarding the former, the surface finishing with high roughness is

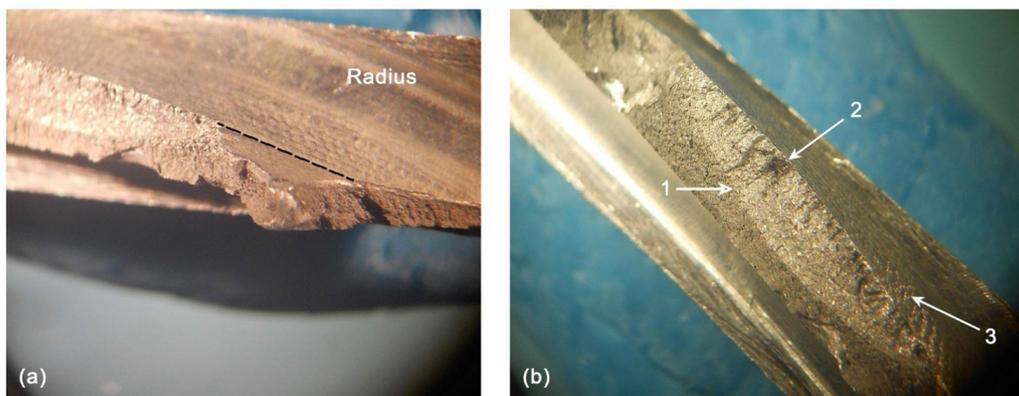
Regarding the difference in shade in the region of the fracture surface, two samples of fractured blades were analyzed in stereomicroscope and SEM to complement the evidence of the fracture mechanism. Figure 4(b) illustrates the fracture surface of one of the samples, which was obtained with a stereomicroscope record and presents highlights to be discussed in the sequence. Again, as shown by arrow 1, it is possible to see the difference in shade between one region of the surface and another. Arrow 2 indicates the possible crack nucleation point. In this region, it is reasonable that the cracks were nucleated by the presence of surface defects which acted as stress concentrators and preferred crack nucleation sites. From this point, the cracks propagate towards the center of the blade until the resistance section no longer supports the mechanical stress, fracturing the component. Finally, in arrow 3, it is possible to see how the outer surface of the blade is finished, which is machined similarly to the metallic body of the turbojet compressor.

Figure 4. Micrographs obtained in stereomicroscope at 16x magnification: (a) fracture surface of a blade and (b) detail of the surface of a fractured blade.

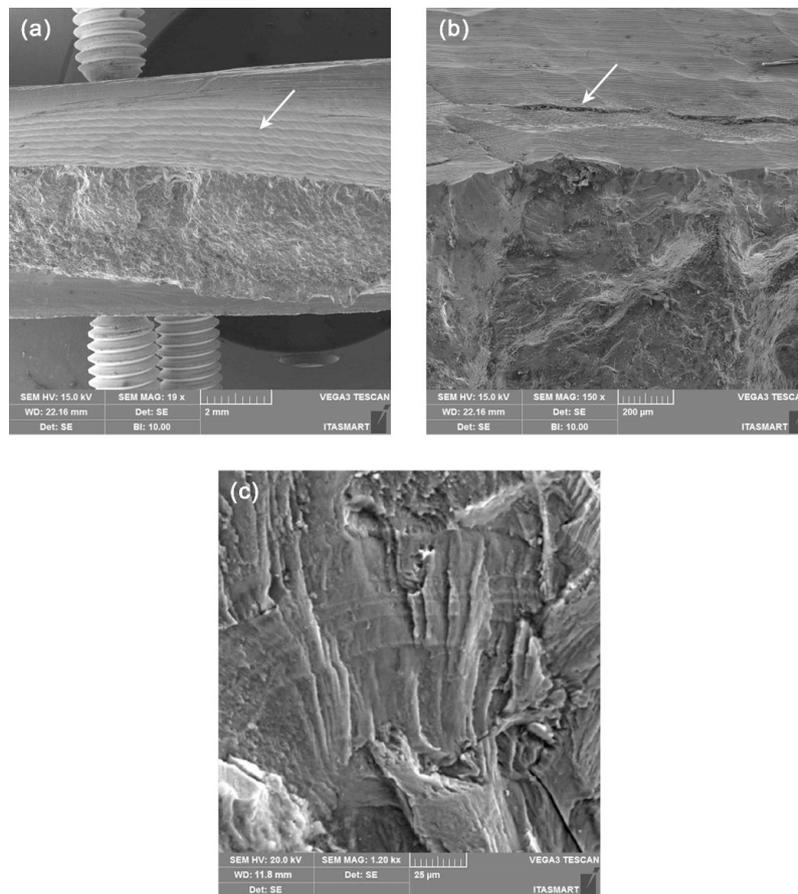
Figure 5 shows SEM images in different positions of a fractured blade. It is evident in Figures 5(a) and 5(b) that the machined surface presents a periodic wavy irregularity that is likely to be the root cause of the failure. The roughness induces the process of crack nucleation and propagation since there is no need for the material to plastically deform and form intrusions and extrusions on the surface of the material so that a crack can then be nucleated and propagated [10]. Furthermore, during the mechanical stress of the material, the loading of forces presents an intensity profile that has a maximum on the surface of the component. Thus, the surface region is subject to greater stresses and any defect and irregularity acts as a stress concentrator and preferential site for crack nucleation and propagation [11]. Something that stands out in Figure 5(a) is that, observing the lateral surface of the fractured blade, the beginning of the crack matches with the region of higher roughness close to the radius of curvature between the blade and the compressor body. This is also clear in Figure 4(a), suggesting again that the crack nucleated in the region of higher roughness. In addition, in Figure 5(b), the arrow points out a microcrack below the fracture surface, also in the region with a rougher surface.

The failure mechanism that led to the fracture of the blades was fatigue, since there is evidence of beach marks and striations. It is worth mentioning that the difference in shade macroscopically visible on the fracture surface of the material is given by the beach marks and a consequence of the different rates of crack propagation, which varies during mechanical stress. This evidence of fatigue fracture was observed in all blades in the first row of the compressor. The nucleation region in most of these blades took place in the soffit side, which corresponds to the high pressure zone. The analysis of the fracture of the blades in the other rows of the compressor was impaired since the surfaces were dented, probably due to the collision with other fractured blades. Knowing the root cause of the failure, it is important to propose a solution to correct the surface finish defects of the machined part, and therefore, the prevention of similar failures.

Figure 5. Micrographs obtained in SEM: (a) overview of the fracture surface of a blade, (b) higher magnification of the previous image and (c) highlight of the stable propagation zone on the fracture surface.

However, in the compressor studied in the present work, the machining of the radius region between the blade and the compressor body proved to be complex, leading to a critical roughness. In view of this difficulty of the machining process inherent to the geometry of the compressor, the “shot peening” process of the machined part stands out as a subsequent step to the machining process and obtaining the “blisk” that can contribute to increase the fatigue life of the part.

As an alternative to prevent the occurrence of failure and with minor impact to the traditional manufacturing process of aeronautical metallic parts, the application of the shot peening technique after the machining process was proposed to be efficient since it acts to increase the surface strength of the part by work hardening and induces residual compression stresses that make the process of nucleation and propagation of fatigue cracks difficult.
