Case study on the failure analysis of turbojet compressor blades

With a turbojet compressor that had its blades fractured during laboratory tests, this work carried out a failure analysis aiming at characterizing the problem, identifying the fracture mechanism and proposing a potential post-manufacturing improvement. Typical steps of a failure analysis were performed, including visual and fractographic analyzes via stereomicroscopy and scanning electron microscopy. The evidence indicated that the component failed due to fatigue, with the presence of very evident striations on the fracture surface, due to a high surface roughness. Therefore, it was considered suitable to propose a shot peening treatment on the product as a way of inducing residual compressive stresses and hindering the process of nucleation of a fatigue crack.

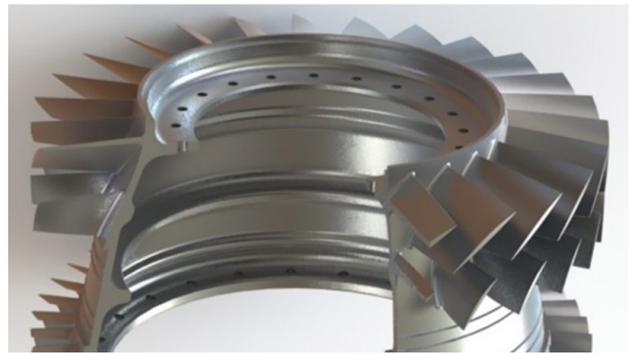
In Figure 3, the set of arrows number 1 again highlights the existing roughness along the surface of the part, which even extends to the region of the surface of the blades. Another discontinuity observed is highlighted

Figure 3. Photographic record of the fractured component, highlighting, in addition to the discontinuities, the fracture surface.

by the set of arrows number 2, where it is possible to identify a difference in shade on the fracture surface of the blades, which has a lighter region in an elliptical shape and the remaining area with a darker shade. Regarding the former, the surface finishing with high roughness is

likely to produce stress concentrators and facilitators of crack nucleation on the surface. Although the surface finishing was visually rough over the entire surface of the compressor, the regions near the exit of the radius of curvature between the blades and the compressor body had a slightly worse finishing. This difference can be noted in Figure 4(a), where a rougher surface is seen above the black dotted line towards the radius. This might be ascribed to some instability during the machining process. The roughness measurements obtained on the surface of a fractured blade and on a surface close to the radius of curvature are shown in Table 1. The mean values of both Ra and Rz are actually higher on the surface close to the radius, although the standard deviation values statistically minimize this difference.
